RenoNix Heater Block Profile

2020.09.03

2. LAM / Novellus C1 / C2 Heater Block

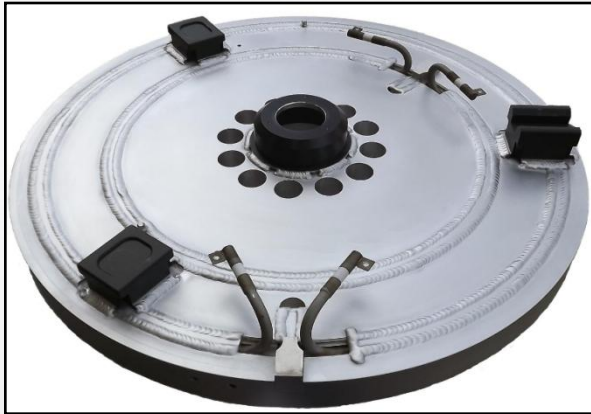
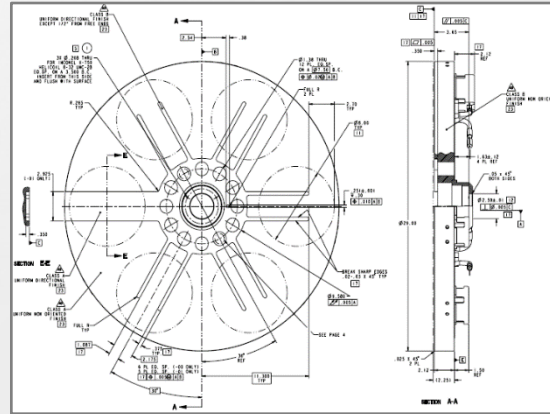
➤ LAM / Novellus Heater Block BKM Drawing as Below.

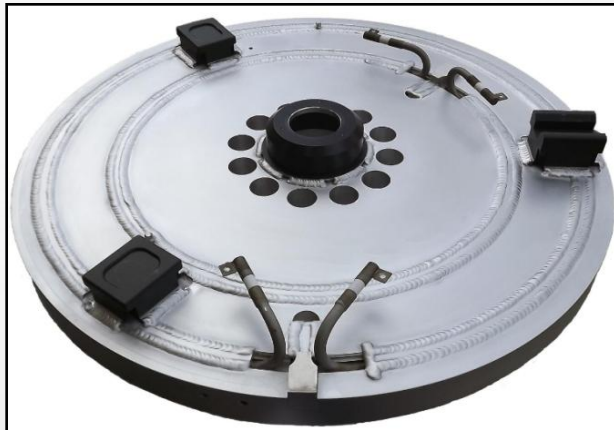
➤ RenoNix H/B Material Characteristics

**Analyzed AL
ingredient of
raw material as below.
it's shown 97.46%**

ITEM	OEM(%)	RenoNix(%)
Al	97.22	97.46
Cu	0.25	0.26
Si	0.68	0.60
Mg	1.03	0.96
Zn	0.05	0.09
Fe	0.46	0.33
Mn	0.07	0.07
Ni	0.004	0.01
Ti	0.02	0.03
Pb	0	0.002
Sn	0.02	0.0003
Cr	0.1	0.15
Etc.	0	0.038
TOTAL		100%

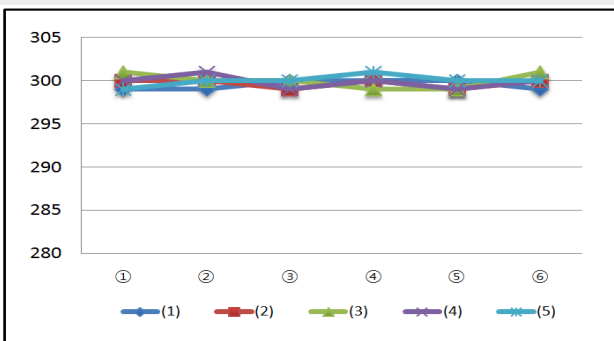
➤ C1 Heater Block Station Temperature Mapping

OEM New Heater Block

ITEM	MAX TEMP	MIN TEMP	RANGE±
①	301°C	299°C	2°C
②	301°C	299°C	2°C
③	300°C	299°C	1°C
④	301°C	299°C	2°C
⑤	300°C	299°C	1°C
⑥	301°C	299°C	2°C

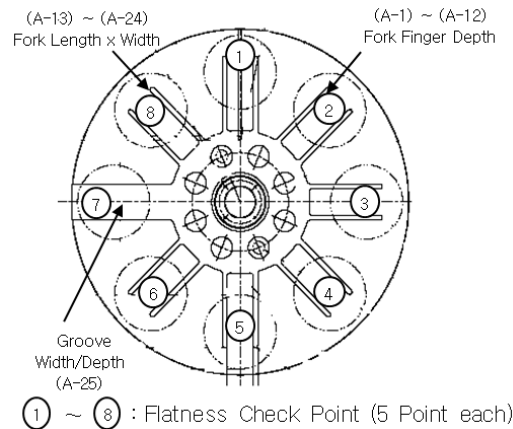
Heater Block time-up condition
Room Temp : 300°C

1. H/B Time-up Condition
2. Temperature Ramp up
Time : 24Min

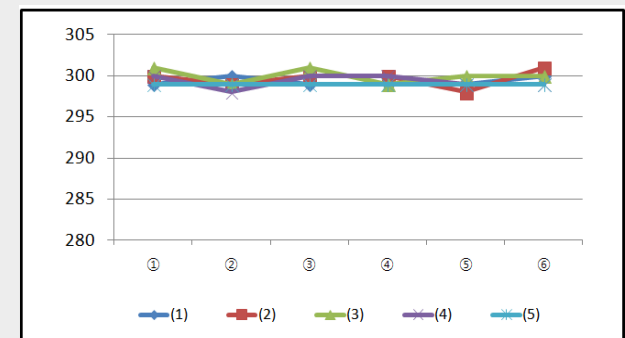
RenoNix 2nd New Heater Block

ITEM	MAX TEMP	MIN TEMP	RANGE±
①	301°C	299°C	2°C
②	300°C	298°C	2°C
③	301°C	299°C	2°C
④	300°C	299°C	1°C
⑤	300°C	298°C	2°C
⑥	301°C	299°C	2°C

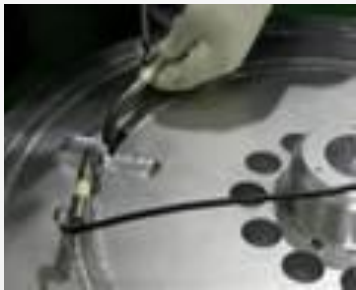
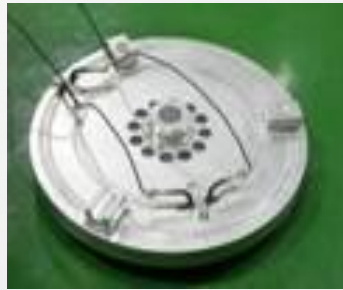
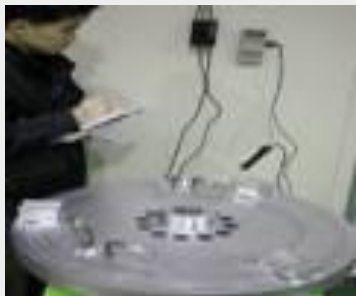
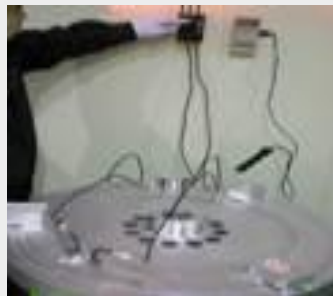
Heat-Up Test Flow

Power Liner Connection

Check the Temp-Time curve

Power Switch - ON and heating up

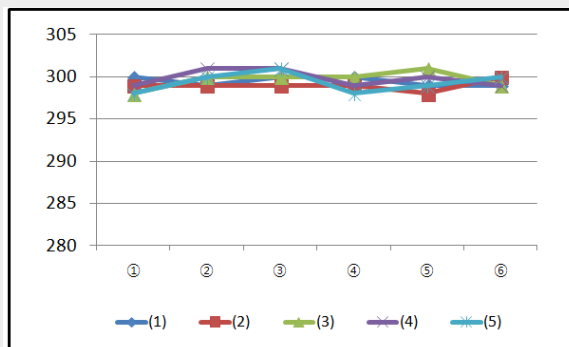
➤ C2 Heater Block Station Temperature Mapping

OEM New Heater Block

ITEM	MAX TEMP	MIN TEMP	RANGE±
①	300°C	298°C	2°C
②	301°C	299°C	2°C
③	301°C	299°C	2°C
④	300°C	298°C	2°C
⑤	301°C	299°C	2°C
⑥	300°C	299°C	1°C

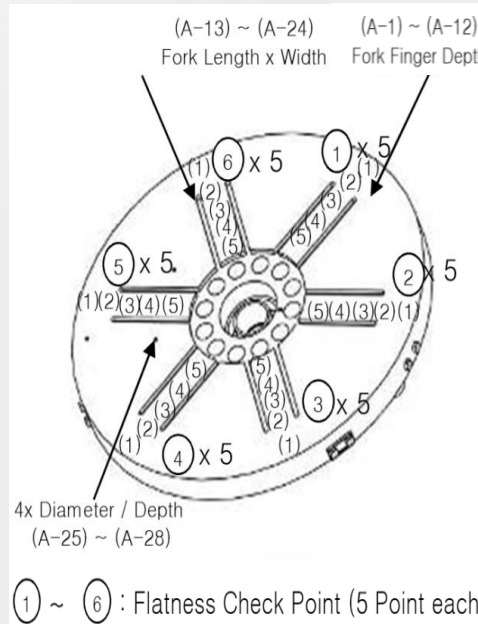
Heater Block time-up condition
Room Temp : 300°C

1. H/B Time-up Condition
2. Temperature Ramp up
Time : 2.5 ~ 4HRS

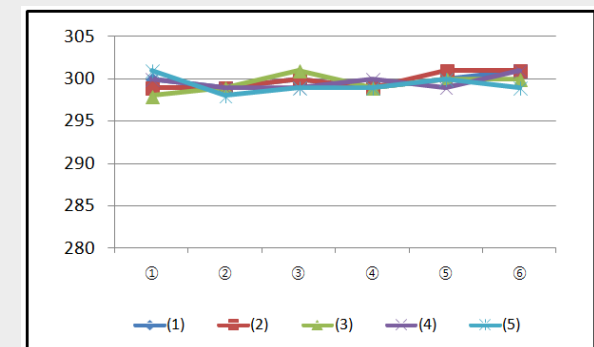
RenoNix 2nd New Heater Block

ITEM	MAX TEMP	MIN TEMP	RANGE±
①	301°C	299°C	2°C
②	300°C	298°C	1°C
③	301°C	299°C	2°C
④	300°C	299°C	1°C
⑤	301°C	299°C	2°C
⑥	301°C	299°C	2°C
